Detailed Process Description

Remediation of Existing Legacy Dumps in Goa

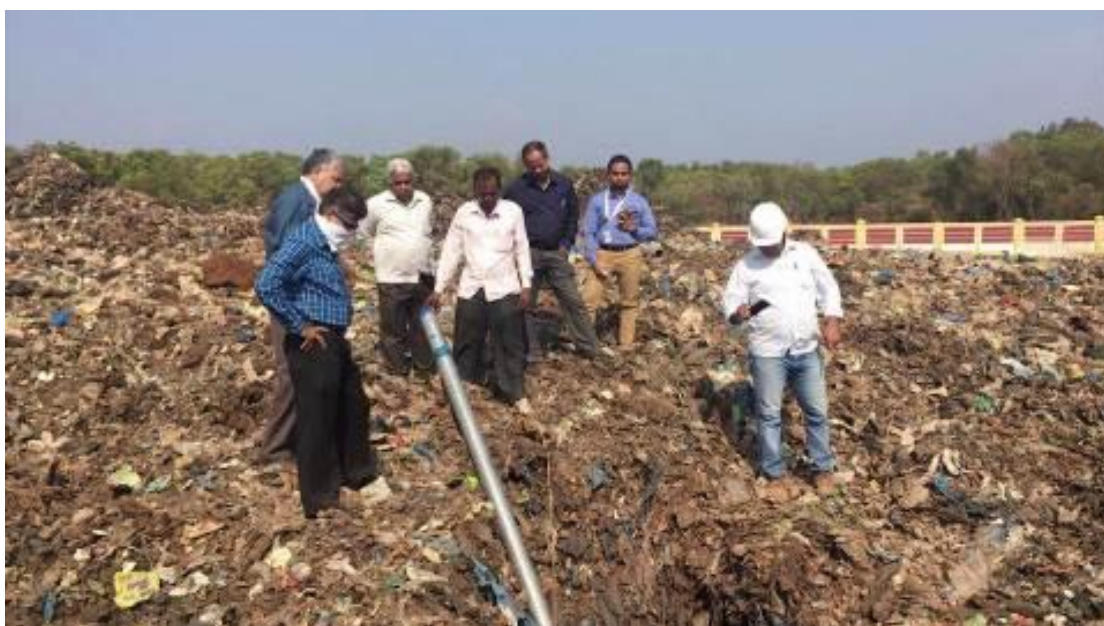
Img. 3: Expert Committee conducting tests at Saligao/Calangute dump site

The proposed remediation process was vetted by the Committee and its suggestions were incorporated. Preliminary trial runs for remediation were conducted at site, by using a mobile Multi Deck Vibratory Screen and Conveyor Mechanism, wherein the waste was screened using 120 mm, 40 mm and 15 mm Screens. Various tests were conducted at NABL / MoEF&CC accredited labs to test the composition of the compost and finalise the method of final disposal of the compost. The over fractions primarily comprised plastic, clothes and inorganic

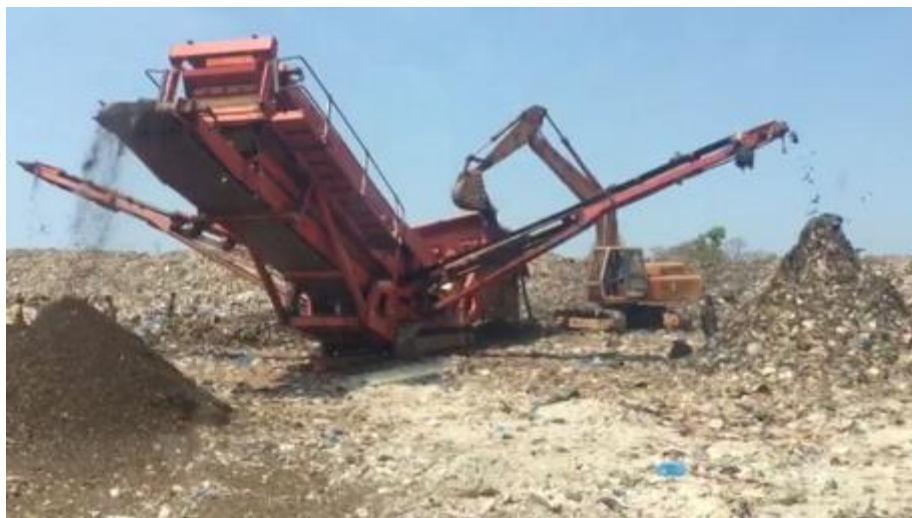
Img-4: Mobile Screen screening the existing Dump at Site

The existing Solid Waste was remediated by mobile “Multi Deck Vibratory Screen and Conveyor Mechanism”. It has multiple Screen Decks having Opening as 120 mm, 40 mm and 15 mm. The existing waste was loaded into the Machine by a Wheel Loader / Crawler Dozer. The waste was then screened and separated into the four fractions as described below:

| 1. | Over fraction of 120 mm Screen | mainly comprising rags, textile and clothes etc |
| 2. | Under fraction of 120 / 40 mm Screen | mainly non-recyclable plastic |
| 3. | Over fraction of 40/15 mm Screen | mainly stones & gravel |
| 4. | Under fraction of 15 mm Screen | mainly inert earth material and soil conditioner / compost |

Both Items 1 & 2 are primarily Refuse Derived Fuel (RDF) and was sent to the Cement Companies for co-processing and Items 3 & 4 was used as a Soil Conditioner / Compost for non-food agricultural trees / social forestry usage. The sample of compost was analysed and test reports are annexed.
